NEWTOWN DAM, BUCKS COUNTY
PENNSYLVANIA

PHASE I INSPECTION REPORT,
NATIONAL DAM INSPECTION PROGRAM

WOODWARD-CLYDE CONSULTANTS
5120 Butler Pike
Plymouth Meeting, Pennsylvania 19462

OVERVIEW
NEWTOWN DAM (SCS PA 621), NEWTOWN TOWNSHIP, BUCKS COUNTY, PENNSYLVANIA

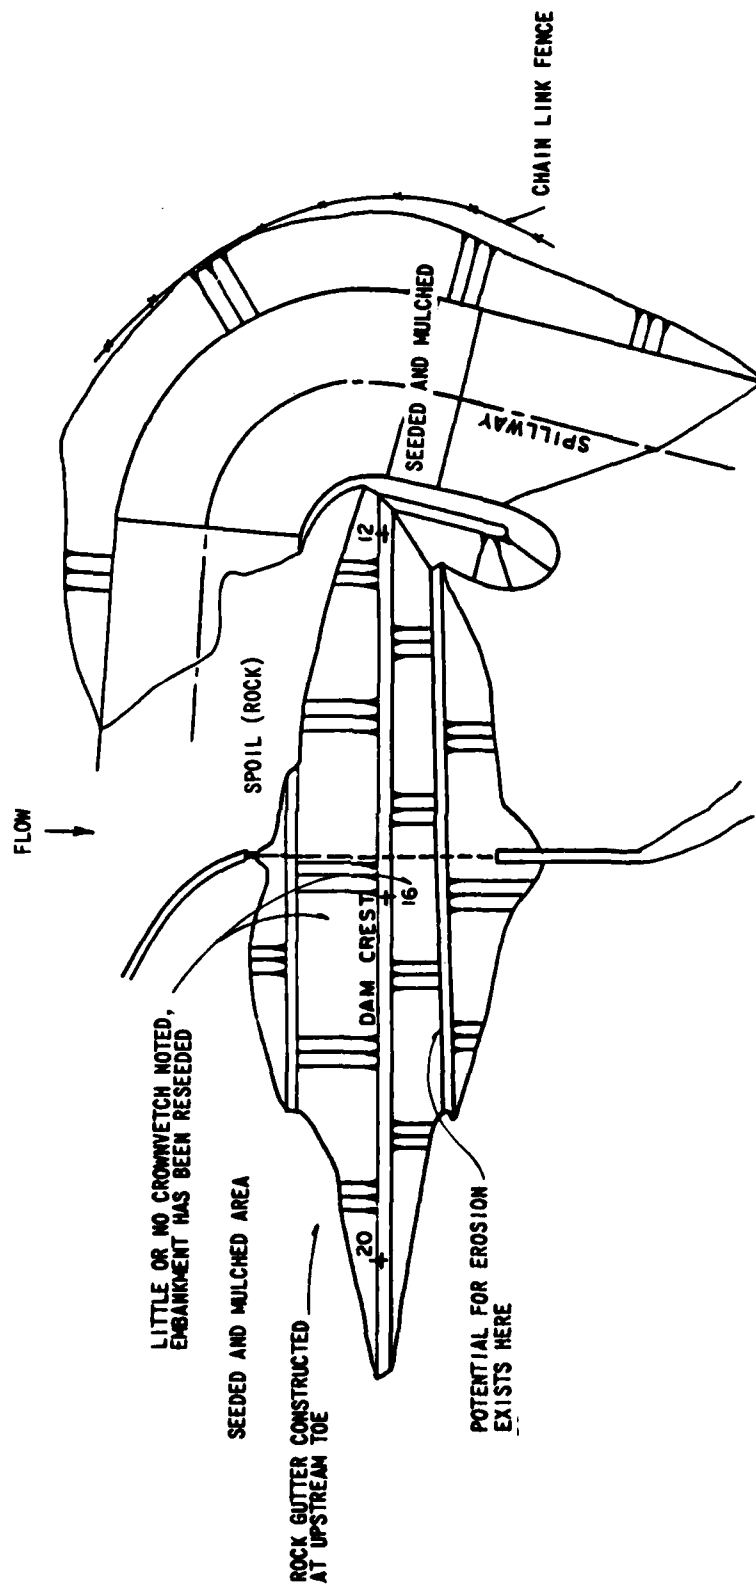
SHEET 5A OF 11

Embankment drains outletting through impact basin walls were dry.
